Historic Motorsport: 917 – 015 (035)

Restoration Documentation: Rear Fuel Hole Description

1971 Spa 1,000km: 917 – 015 (035)

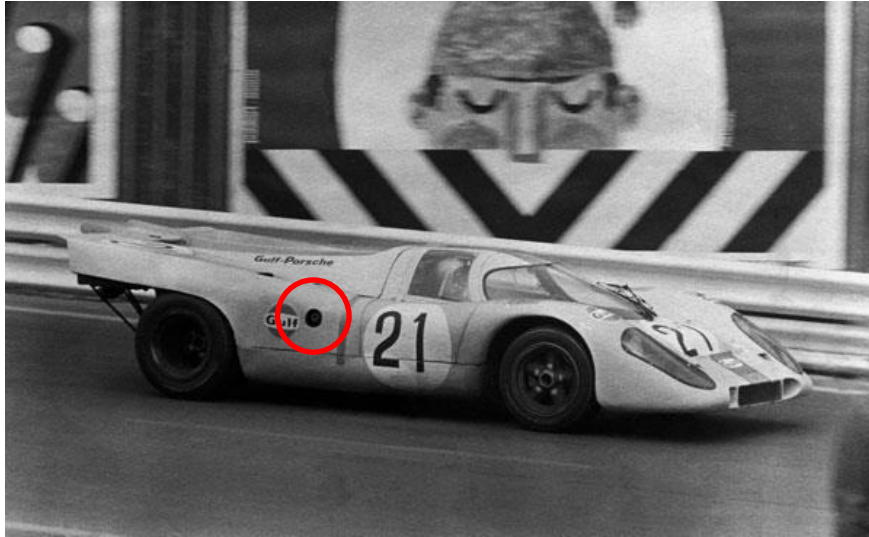
Shows the 917-015/035 racing at 1971 Spa 1,000km with fuel overflow hole in the right side of the rear tail

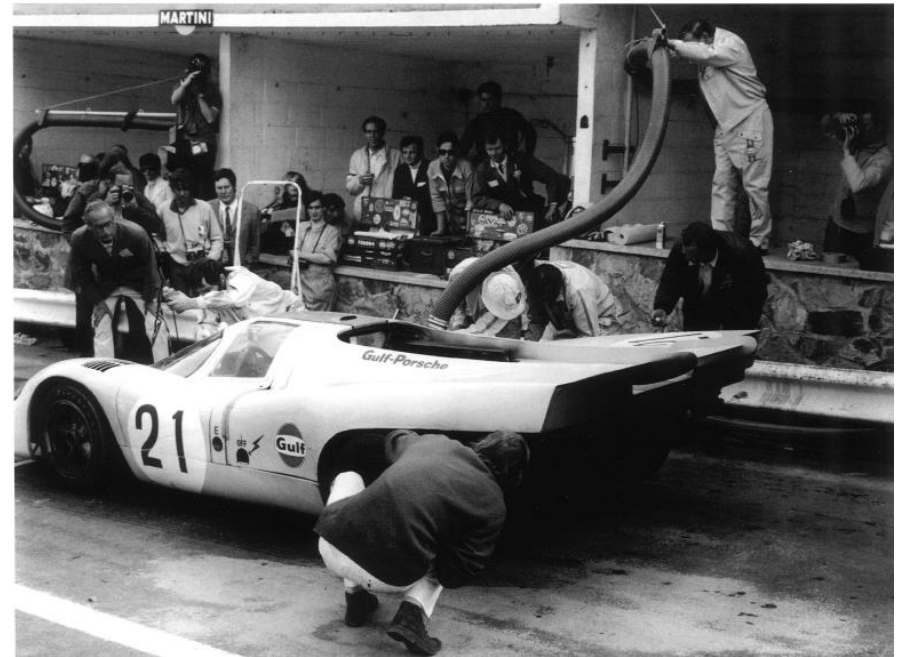
Shows large nozzle with gravity fed fast fueling at 1971 Spa 1,000km. Note the gentleman to the right of the hose holding the overflow bottle while the fuel filler adds fuel with the hose

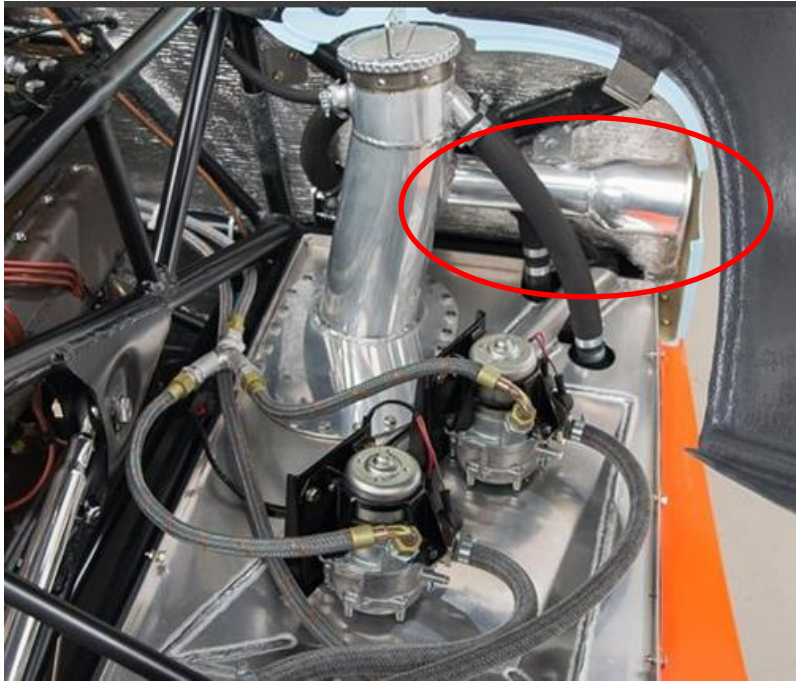
**Shows side breather example
on 917-004/017**

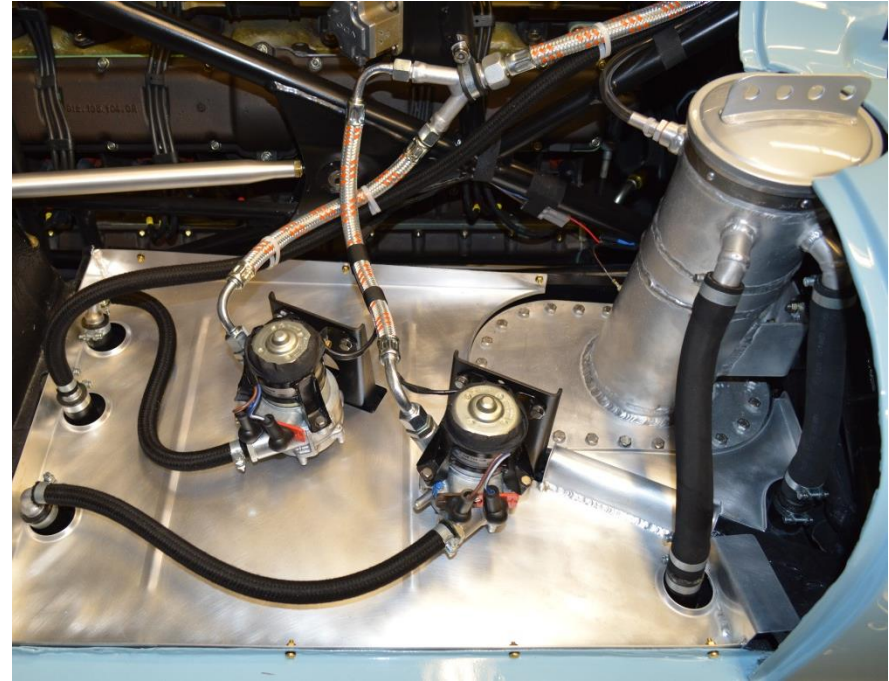
Shows NO side breather on 917-015/035

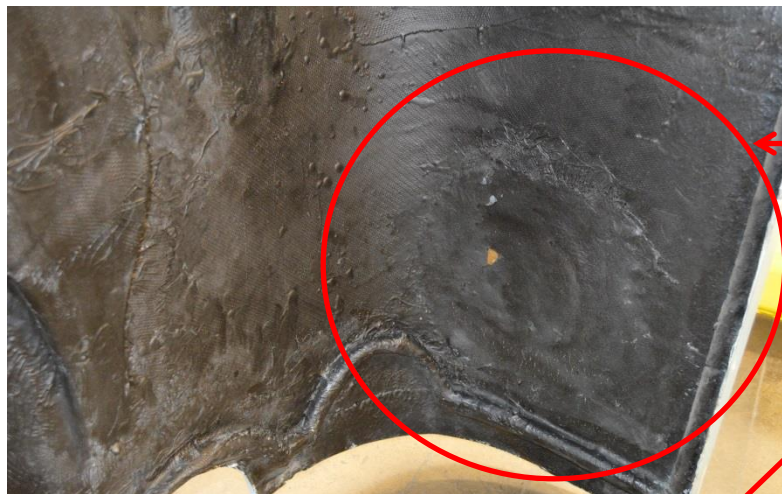
Rear Tail Patches - detail

Shows hole on the right side of the tail now patched up
